## Ford 6.0L Power Stroke Injector Failure Prevention

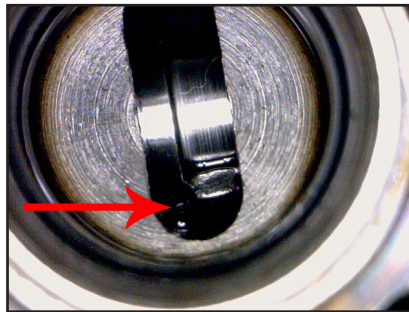
A common failure mode of the 6.0L Power Stroke injector is a dead misfire from a spool valve stuck in place by a piece of metal. See illustration #1 with a view looking down the injector's high-pressure oil inlet a piece of metal can be seen wedged in a spool valve groove. The removed piece of metal is shown in illustration #2.

When an injector is removed the oil inlet and spool valve should be inspected for the presence of metal. If metal is found the check valves should be inspected, replaced as needed, the oil rail flushed and the injector replaced.

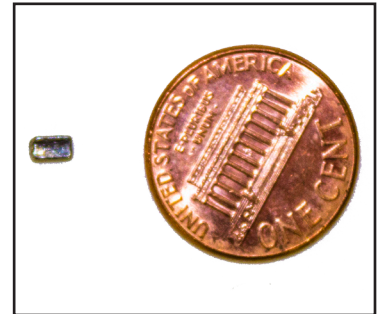
#2

Side-by-side with penny for comparison.

The question has been: Where does the metal come from? The source of the metal is the check valve located in the high-pressure oil system prior to the oil rails. On the 2003 model year with the log oil rail, the check valve is located in the oil rail inlet fitting. In the 2004 model year, the wavy rail was introduced and the check valve is located in the high-pressure stand pipe. On later 2005 and up model years, the check valve is located in the oil rail rear support plug.
